Manhole Inspection Summary

Manhole # S19AA1001MH

Insp Date: **3/13/07 2:25 PM**

Location Address: **2200 DRUID PARK DR**

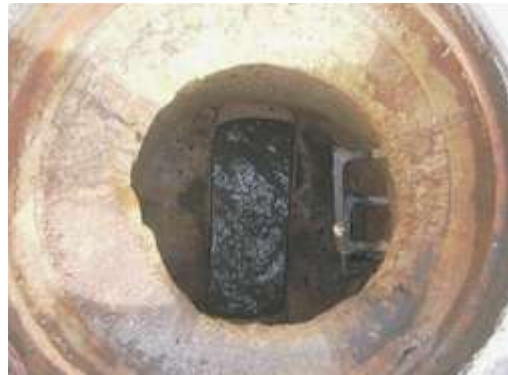
Top View

Bench debris.

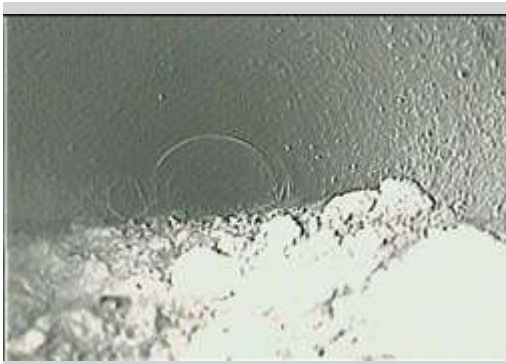
Inside the I9

Comments **The O12 and the I9 pipe pictures show that the cementitious lining is beginning to deteriorate in the Barrel.**

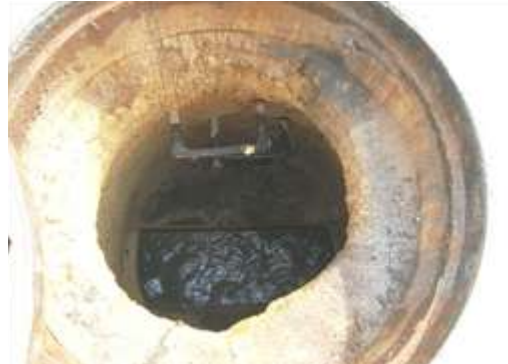
Defect

Frame leaks. Frame offset. Adjustment infiltration - other side.

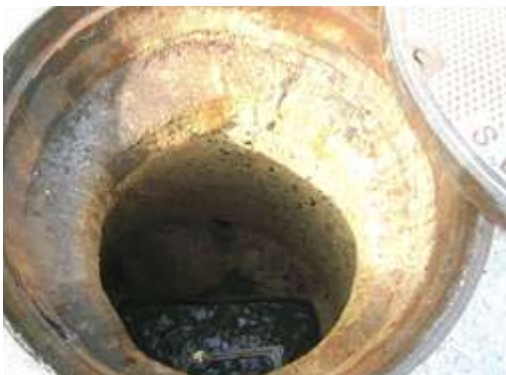
Defect

Frame leaks. Frame offset. Adjustment infiltration.

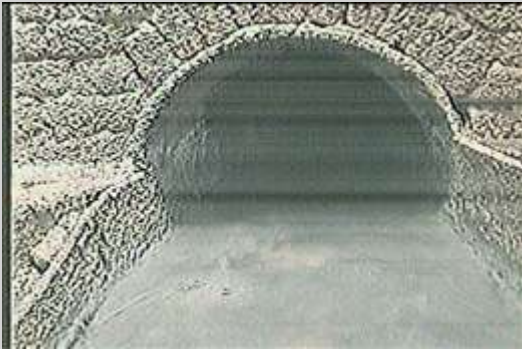
18 in. Circular Gravity Sewer Pipe Out @ 12 O'Clock

Deposits: ☐ None ☐ Mud ☐ Sludge ☒ **Debris** ☒ **Grease**

Silt Depth: **2** (in.) Deposits Extent: **Medium**

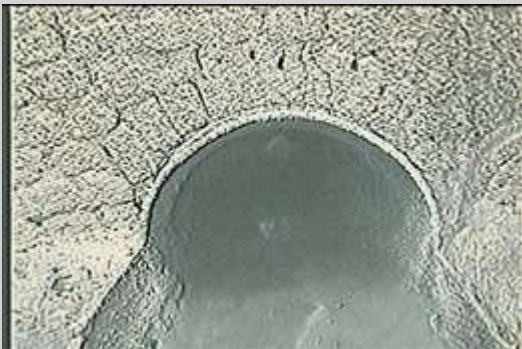
18 in. Circular Gravity Sewer Pipe In @ 6 O'Clock

Deposits: ☐ None ☐ Mud ☐ Sludge ☒ **Debris** ☐ Grease

Silt Depth: **1** (in.) Deposits Extent: **Medium**

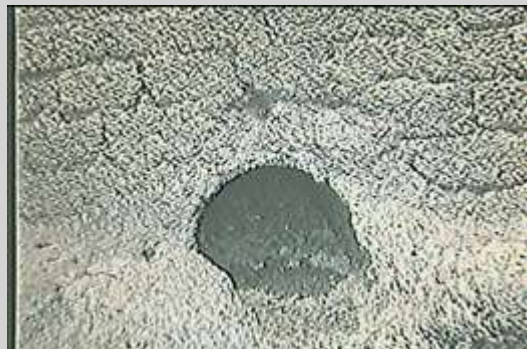
Pipe In @ 9 O'Clock

Deposits: ☐ None ☐ Mud ☐ Sludge ☒ **Debris** ☐ Grease

Silt Depth: **2** (in.)
